Watershed Inventory Siem Reap, Cambodia: A Combination of Social and Natural Science Methods

Harald Kirsch

Abstract: The population in the Stung Siem Reap Watershed in Northern Cambodia is suffering from the declining quality and quantity of their water resources. A Watershed Inventory was undertaken to identify the main causes and to provide local planners with comprehensive information on watershed issues, including land use changes and their consequences. Hereby the combined application of environmental, hydrological, and socio-economic survey methods – supported by GIS application – proved to be successful to detect sand excavations from riverbanks and the continuous depletion of forests as having a major negative impact on water resources. This methodology also helped to explain upstream – downstream relationships and climate-related phenomena like floods and droughts. To ensure a more sustainable development in the future, the main objective of all actions must be to stop the severe destruction of the natural resources, which has foreseeable consequences for the socio-economic system of the watershed.

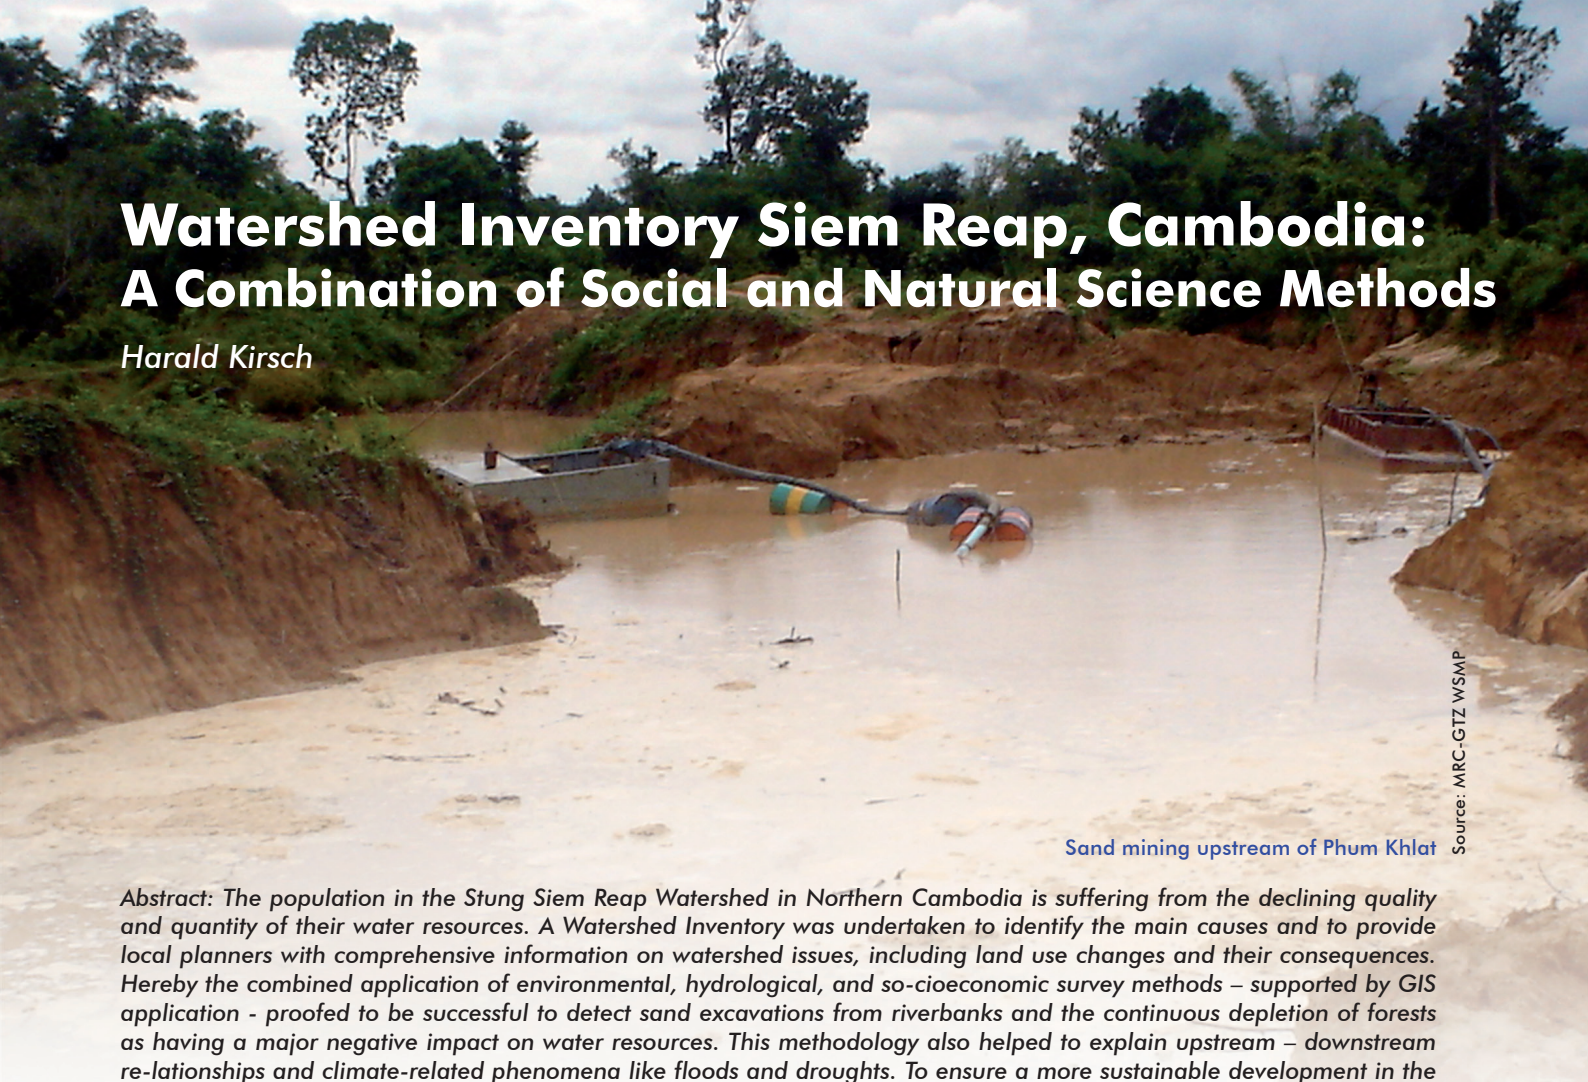
Sand mining upstream of Phum Khat

Sand excavation, soil erosion from cleared land and river bank erosion lead to an increase of suspended and sediment load. GIS mapping that included information from field surveys, analysis of SPOT satellite images, and turbidity data of water samples (turbidity tube) finally proofed what previously has been stated by interviewed villagers and workshop participants: the excavation of sand for construc-

tion purposes was identified as a major reason for water pollution in the whole watershed. The mining operators showed total disregard for any law. If these practices would continue, the resulting high sediment and suspended load in the rivers will certainly have a negative impact on all kinds of water utilization. It can even lead to a breakdown of the function of water take-off channels. Reservoirs and rivers already have increasingly been silted, which caused frequent floods in the town and droughts in agricultural areas (JICA 2006).

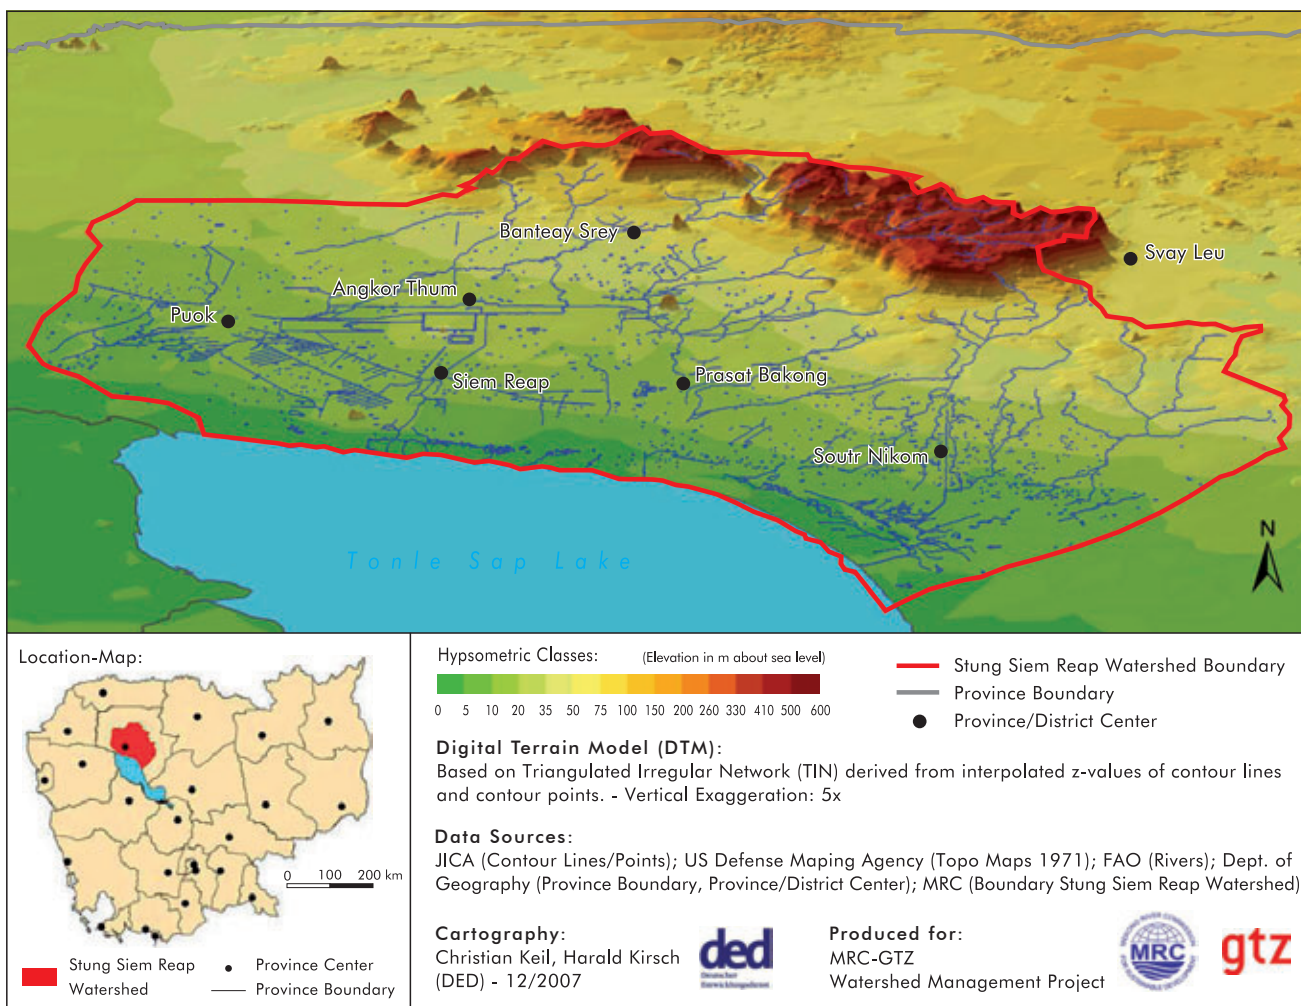
Fig. 1: Digital Terrain Model of the Stung Siem Reap Watershed

world-famous historic temple of Angkor Wat. It comprises an area of 3,619 sqkm and extends from the mountain range of Phnum Kulen to the Tonle Sap Lake (Fig. 1). The elevations in the upstream area of Phnum Kulen reach up to 500 m asl, whereas the town of Siem Reap in the downstream area is located only at 15 m asl.

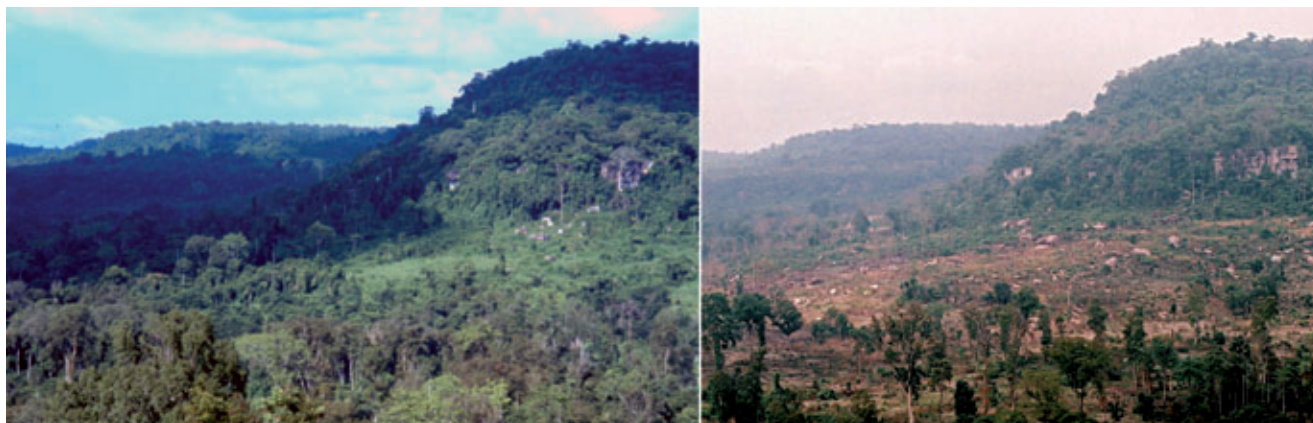
Forest depletion at the northern slope of Phnum Kulen between Oct. 2003 (l) and Apr. 2008 (r)

sons. The survey indicated the likely involvement of the military, police and politicians. On the other hand there are poor farmers who are engaged in illegal logging for subsistence. Large evergreen forest areas within the Kulen National Park have been cleared since the end of 2003. Some of the depleted area has been converted into orchards, on others slash and burn is practiced; others just remain fallow and will change into shrub or grassland.

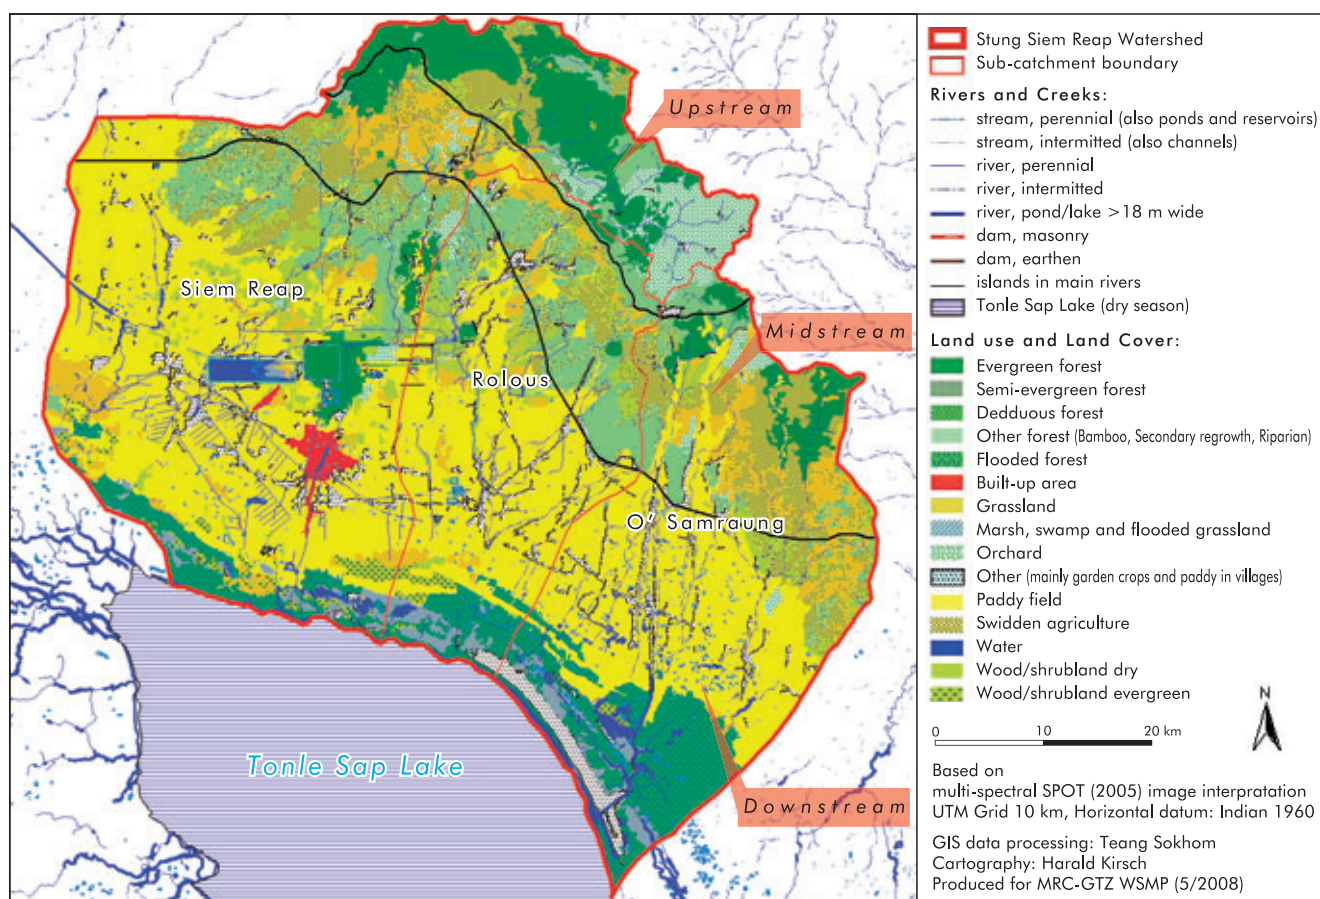
Fig. 2: Land Use Map of Stung Siem Reap Watershed

Based on hydrology and topography, the watershed has been subdivided into the 3 sub-catchments: Stung Siem Reap, Stung Roluos, and O' Samraung (Fig. 2). Furthermore, the whole watershed (incl. the sub-catchments) was subdivided into 3 major landscape units (KIRSCH et al. 2008): 1) The Phnum Kulen sandstone plateau is defining almost the entire upstream area of the watershed; 2) The undulating midstream area with a complex geology (volcanic rocks, sandstone, and sandy sediments with laterite) extends 10-20 km from the foot slope of Phnum Kulen towards SW; 3) The flat downstream area is located on alluvial fans which stretch with 0-2% inclination towards SW until the Tonle Sap

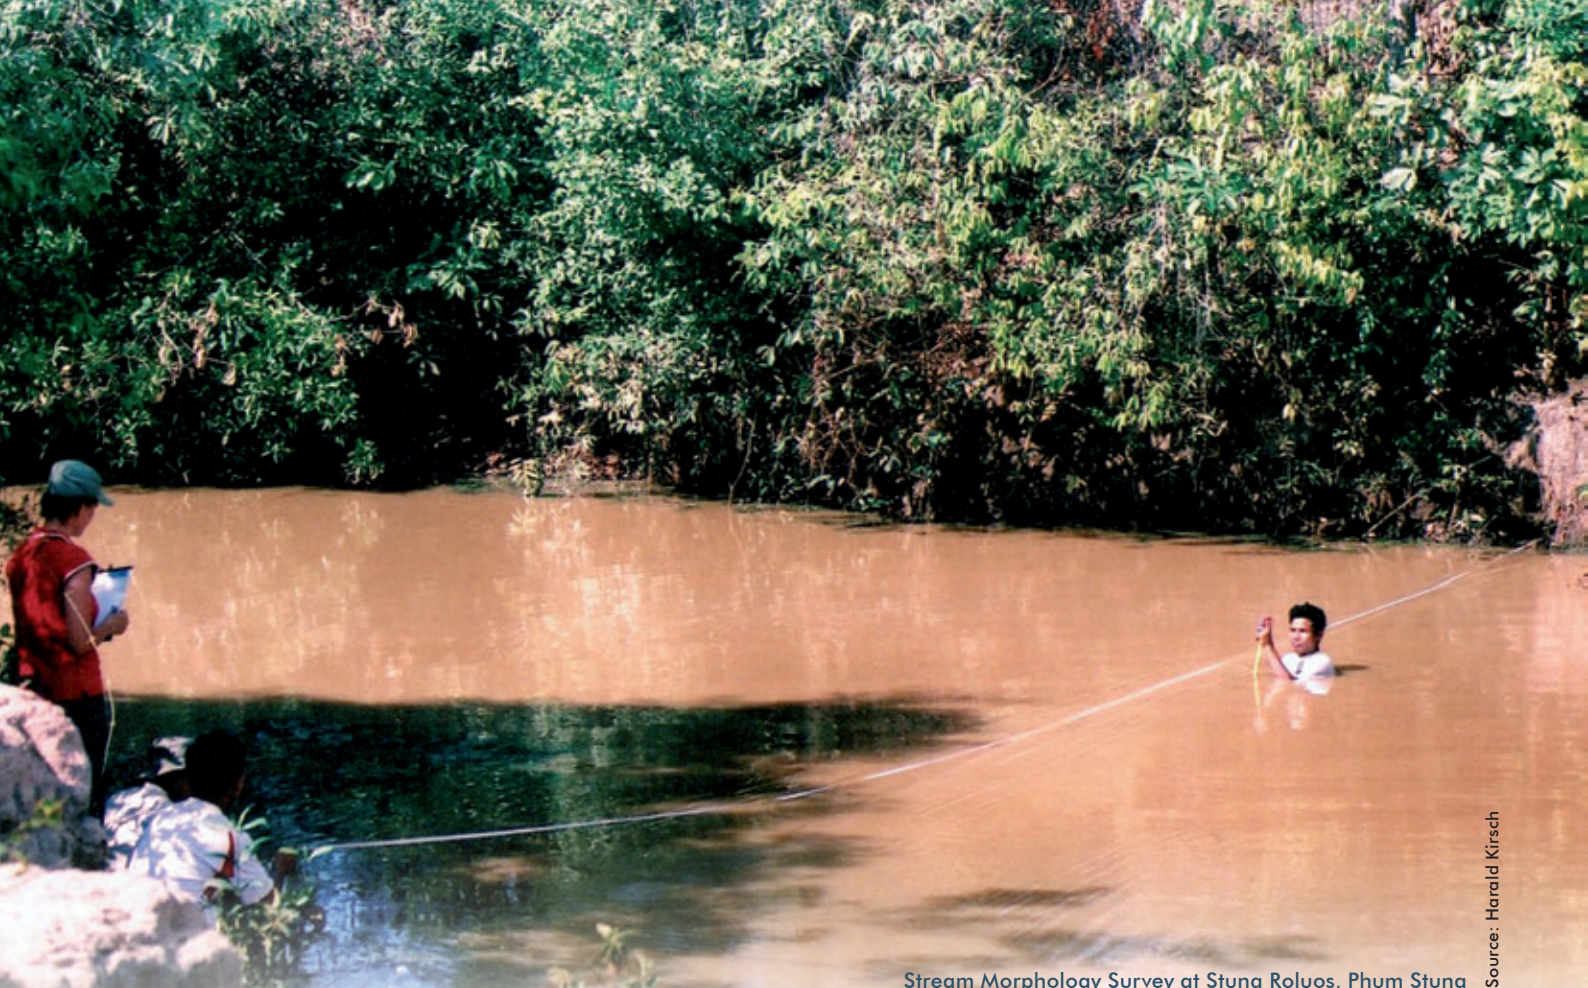
Stream Morphology Survey at Stung Roluos, Phum Stung

The width and depth of the rivers and creeks vary within a short distance according to the riverbed characteristics, relief and geology. They are between 1.50 m to > 20 m ca. wide, and between 10 cm to almost 2 m deep (dry season). In the rainy seasons all streams in the pilot watershed flow into the Tonle Sap Lake, but since 10 years O' Samraung is completely seared in the dry seasons.

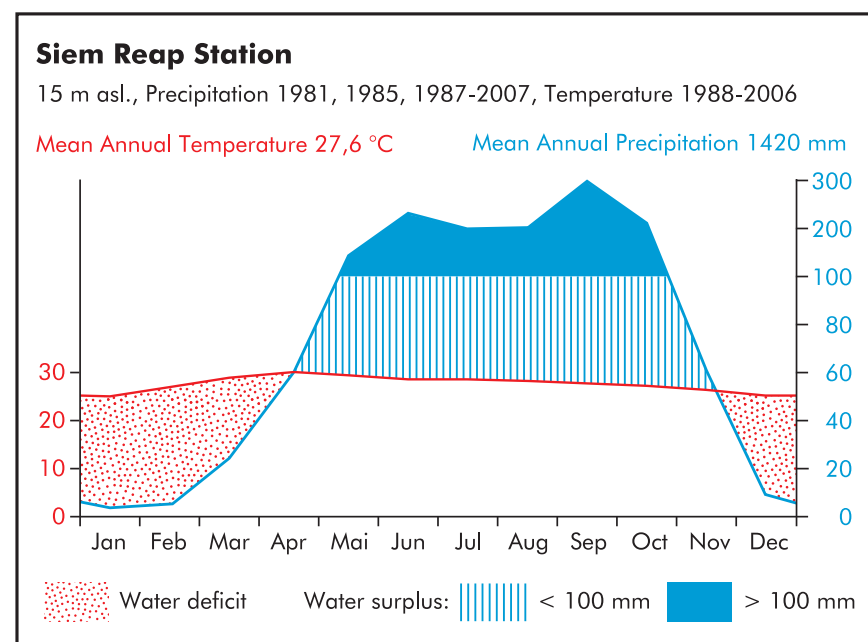
Fig. 3: Climate Diagram of Siem Reap Station

Data Source: Prov. Dept. of Water Resources & Meteorology, Siem Reap
 Pacific News Design: © Claus Carstens 2010

The climate of the area investigated is determined by the Asian monsoons. The rainy season lasts from May to October (Fig. 3). The natural climatic variability is quite high; the beginning

of the rainy seasons can be as much as one month too early or too late. The amount of monthly and yearly rainfall and the number of rain days can naturally vary from year to year (Siem Reap station: 1179 – 1765 mm/year, average 1420 mm; 58 – 177 days/year, average 136 days). This is causing problems for the widely practiced rain-fed agriculture. There is also a pronounced spatial variation of precipitation in the study area, caused by wind directions and orographic influence. The mean annual rainfall ranges from 1093 mm in Bantaey Srei to 1828 mm on Phum Kulen. The temperatures range between 10.7 °C (min.) in the cold season in December to 40.8 °C (max.) in April. The annual mean temperature in measured at Siem Reap station is 27.6 °C.
